# **FUEL SYSTEM DURABILITY— U.S. COAST GUARD**

**INTERIM REPORT  
TFLRF No. 393**

**U.S. Army TARDEC Fuels and Lubricants Research Facility  
Southwest Research Institute® (SwRI®)  
San Antonio, TX**

**Contract No. DAAE-07-99-C-L053 (WD20)  
SwRI Project No. 08.03227.20.001**

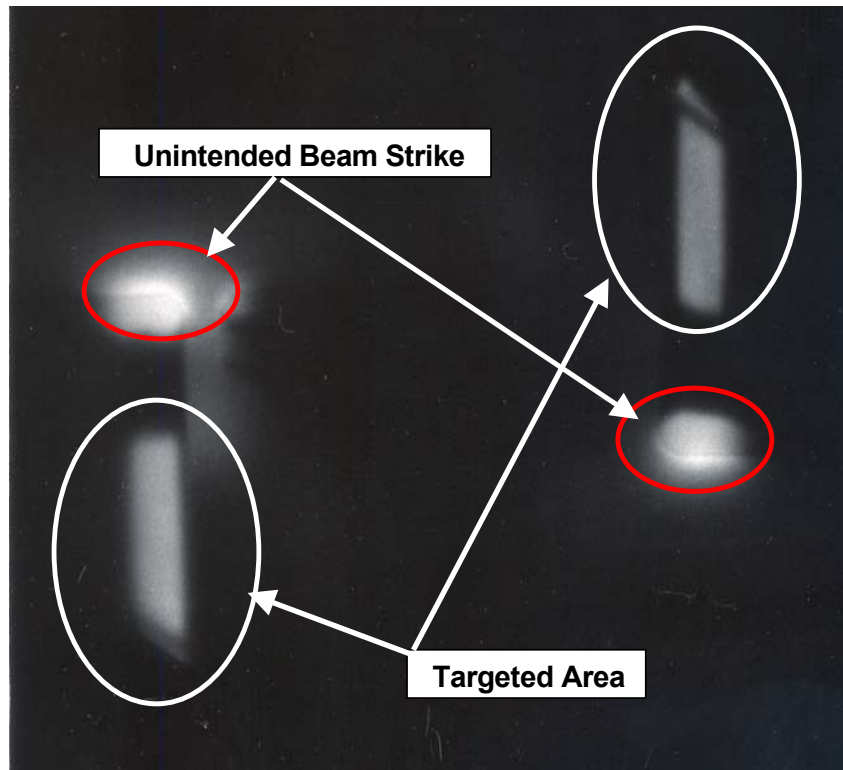
**Figure 11. Radiograph Showing Target Area and Unintentional Activation**

Examination of the radiograph indicates the activity is high because the beam struck an unmasked vertical edge of the plunger. It is likely most of the activity measured is on the vertical surface, normal to any wear surface. Figure 11 does show activity in the target area, but SwRI cannot separate the activity from that area with the detectors. Furthermore, the activity depth profile is unknown due to the beam strikes on the different surfaces. It appears the mask was not extended far enough along the length of the plunger to block the beam from an unintentional strike (9). The subcontractor acknowledged their error, and will activate another plunger at no cost.

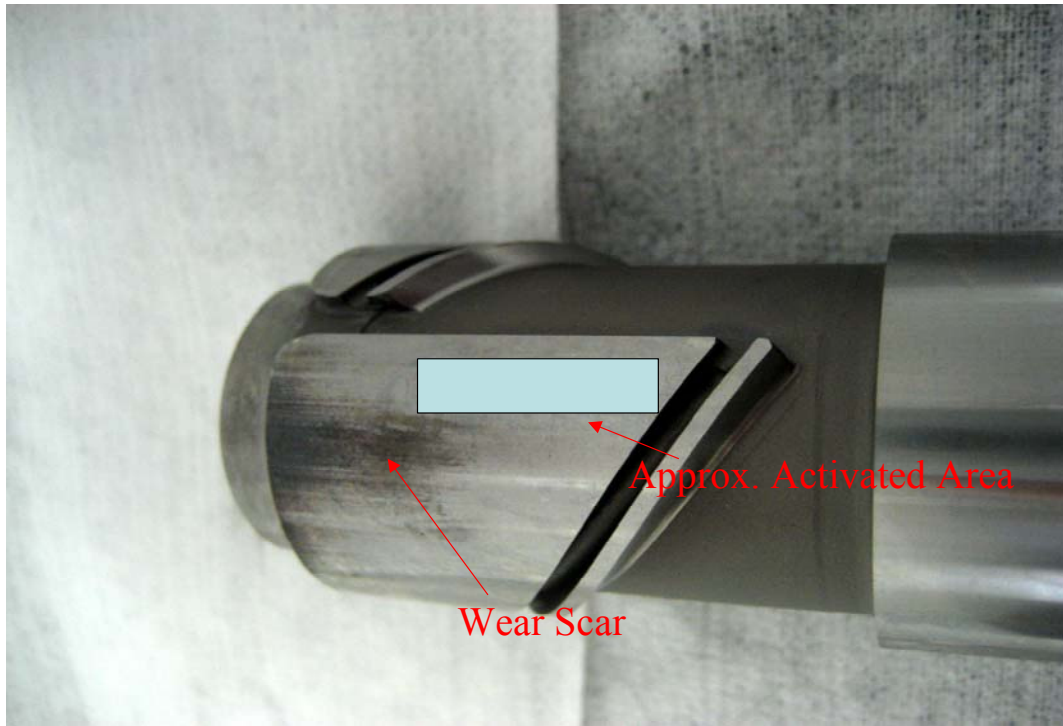
Upon examination of the plunger to check activity it was noted a polished wear scar (Figure 16) was forming on the plunger. However, the wear scar development appears to miss the activated area of the plunger. The wear scar had not been noted prior to the JP-5 operation. However there is not any documentation to specifically indicate the scar was solely due to JP-5 operation. The location of activation was in an area indicated by DUAP as a high wear area. A possible cause for the deviation from that area is the drive system will not steadily hold pump speed above a 3/4-rack position. The wear scar appears to correspond to a position that represents 3/4-rack. Options for testing include running at 3/4-rack as with the other fuels to see if the poor lubricity fuel will affect the plunger wear regardless of the rack position. The other option was to allow greater speed variability and operate as close to full-rack as possible.

**Figure 16. Developing Plunger Polished Wear Scar**

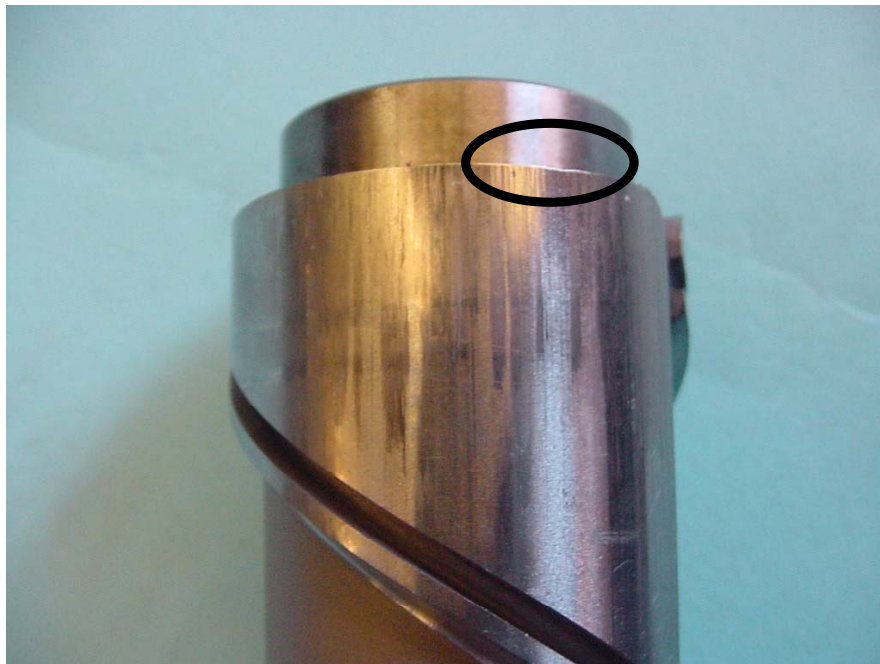
The plunger was pulled and an activity analysis indicated approximately 0.5-microns of material was removed from one side of the plunger. The other side showed activity levels in the statistical level of the readings. Inspection of the plunger indicated the wear scar had moved to the position desired. Unfortunately it appeared chips along the top edge of the plunger broke off and caused third body wear between the barrel and plunger, shown in Figure 17. The shiny edge indicated in Figure 17 is one location of a chip that flaked off. Figure 18 is picture of the mating barrel showing the effects of the third-body wear, and flakes or debris in the barrel. Inspection of the area shown in Figure 18 revealed the wear area to be pitted, like part of the barrel chipped out. Pitting is usually related to cavitation wear in fuel injection systems, and is usually seen in injection lines. SwRI investigated this wear between the barrel and plunger and documented the wear surfaces with Talysurf surface profilometer measurements to verify the surface conditions.

**Figure 17. Sulzer Plunger with Wear Scars Formed from Third-Body Wear**

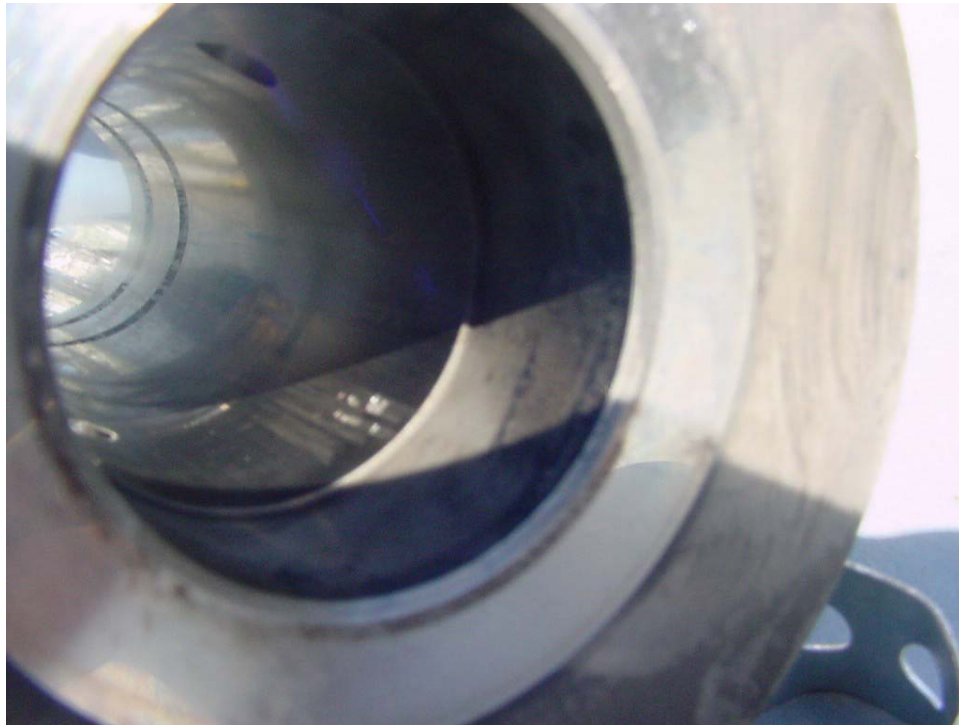
**Figure 18. Wear Scars in Injection Pump Barrel**

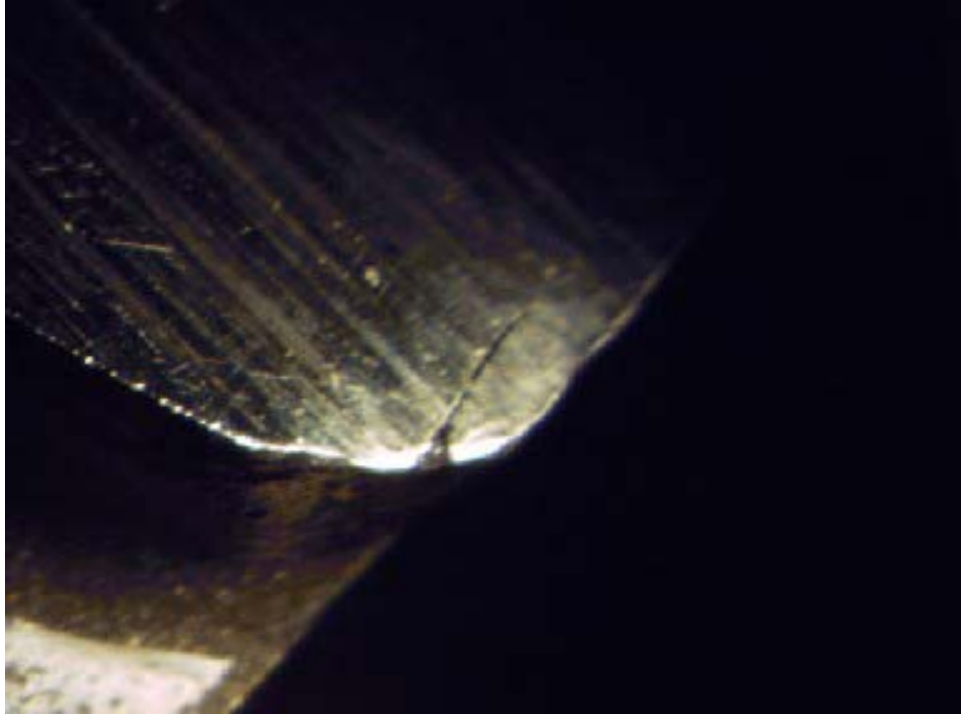
Several photographs documenting unusual wear have been taken. Figure 19 is a photograph of one of two cracks found on the plunger helix. The crack is on the top edge that would travel across the pits that formed in the barrel. Evidence suggests that a ridge was forming on the lip of the plunger, and some of those lips may have chipped off. The ridge that appeared to form was not radial, but extended axially along the top edge of the plunger. The other crack found on the top of the plunger helix is shown in Figure 20. This area is around the idle position on the plunger. The area looks like a lip has formed and is in the process of chipping off.

**Figure 19. Sulzer Injection Pump Plunger Crack Formed at Edge of Helix**

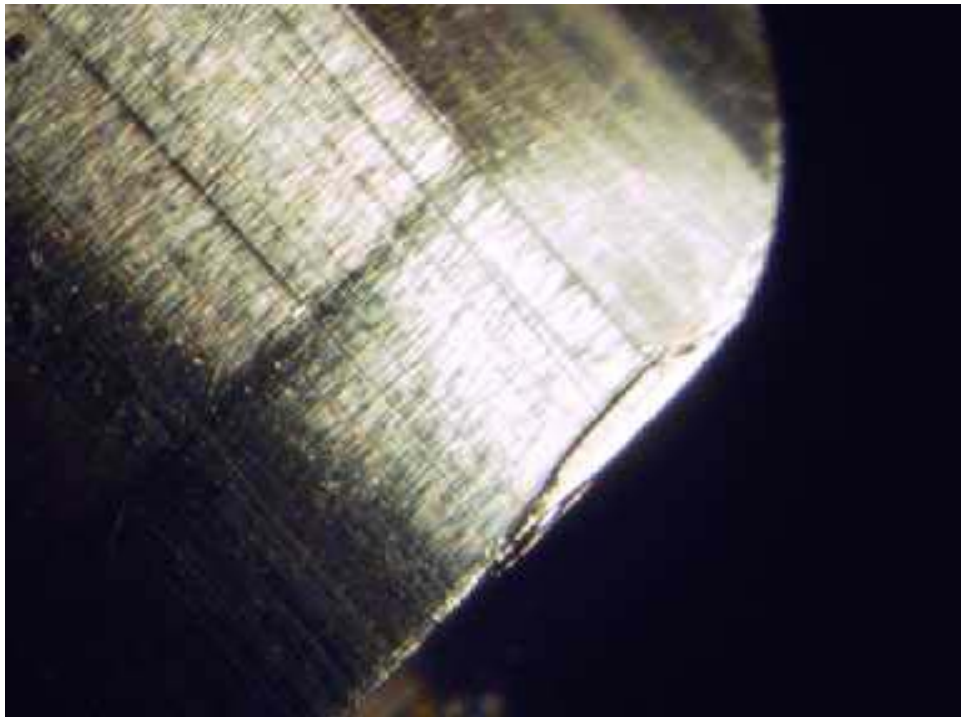
**Figure 20. Second of Two Cracks Found on Sulzer Injection Pump Plunger Helix**

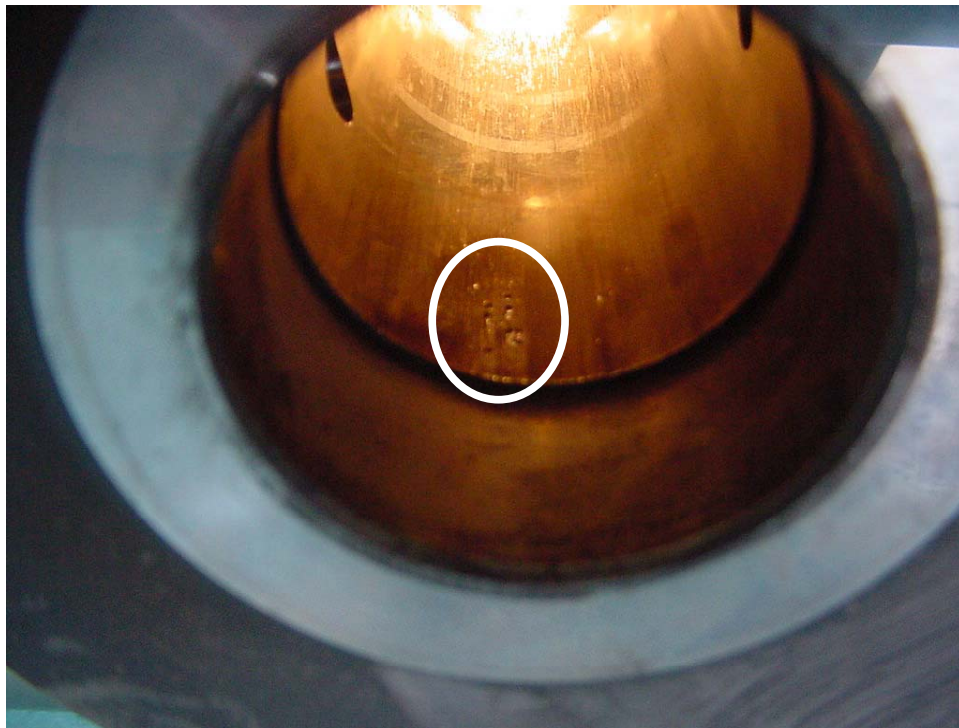
SwRI looked for references that concern the conditions for cavitation in fuel injection barrel and plungers as they relate to the operating conditions, fuel viscosity, and fuel volatility of the surrogate JP-5 test. Cavitation in fuel injection equipment results in pitting due to surface fatigue in a localized area. The backlighted view of the same area in Figure 21 make the pits stand out due to the shadowing. Also seen in the backlighted view are some annular wear patterns that may correspond with machined areas on the plunger.

**Figure 21. Sulzer Barrel with Shadows Revealing Pitting**

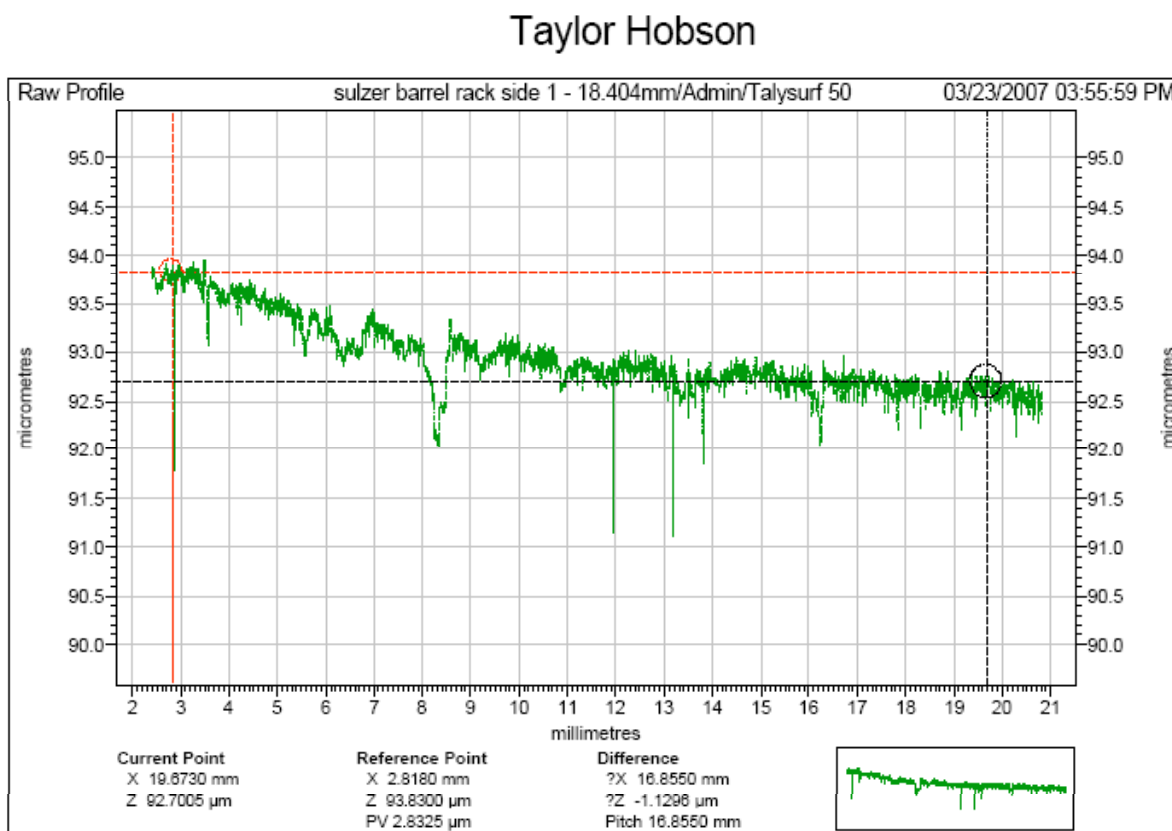
The Talysurf surface profilometer trace shown in Figure 22 suggests there is bell-mouthed wear towards the top of the barrel. The wear is about 1.1-microns for a 18mm stroke from the bottom of the barrel on the left, towards the top of the barrel.

**Figure 22. Surface Profilometer Trace of Barrel after being Leveled Showing Bell Mouth towards Top of Stroke**

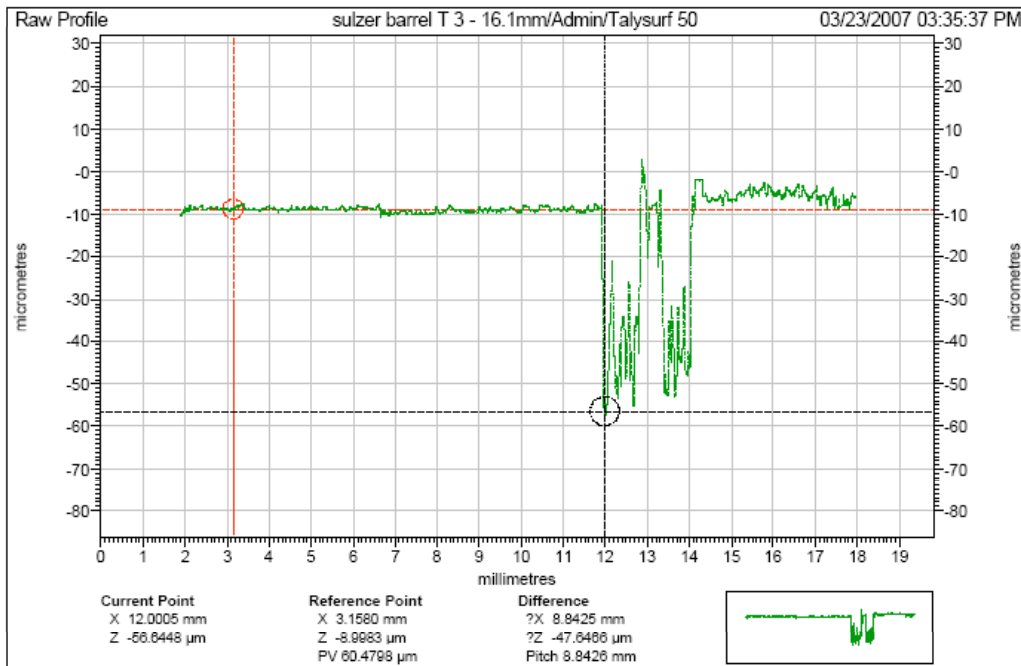
material by the plunger towards the top of the barrel. The ploughed material is likely what caused the severe wear on the plunger.

Figure 23. Surface Profilometer Trace across Pit from Injection Pump Barrel

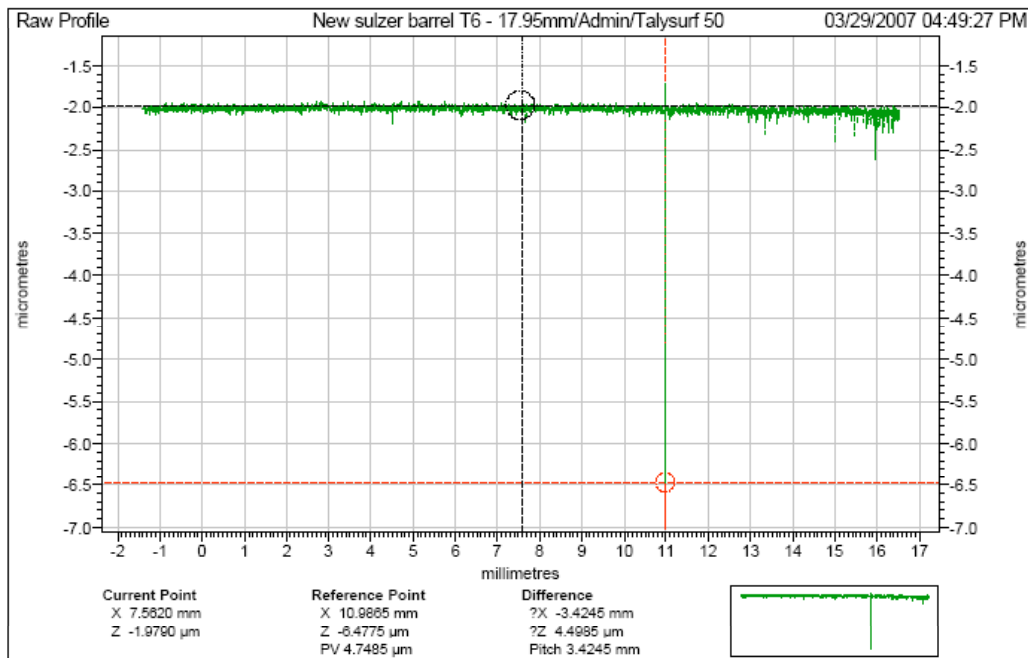
Figure 24 is a profilometer trace for a barrel that had the plunger activated improperly. This barrel only had 20 hours of break in operation on F3000 fuel. It is uncertain what the spike is because it is not visible to the eye. The trace indicates about 0.1-micron wear. At these small values the levelness of the component measured can show up as slight slope, but the trace appears to bell slightly towards the top of the stroke.

Figure 24. Surface Profilometer Measurement on a Low Time Barrel Operated on Diesel Fuel

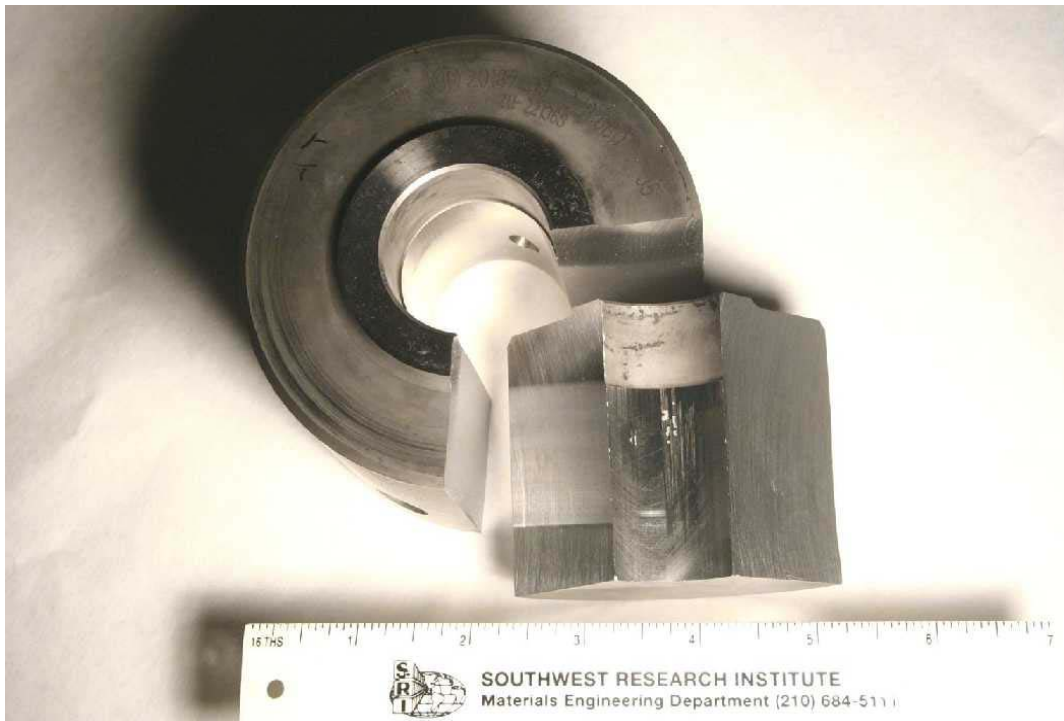
The barrel and plunger were sectioned and examined in a Scanning Electron Microscope (SEM) to determine surface condition and elements in the worn areas. Areas examined included the base metal in an area without any wear, an area that appeared to undergo normal wear, and the scuffed area. Figure 25 shows the section barrel, with the scored area that was examined.

**Figure 25. Sectioned Barrel with Scuffed Area Examined**

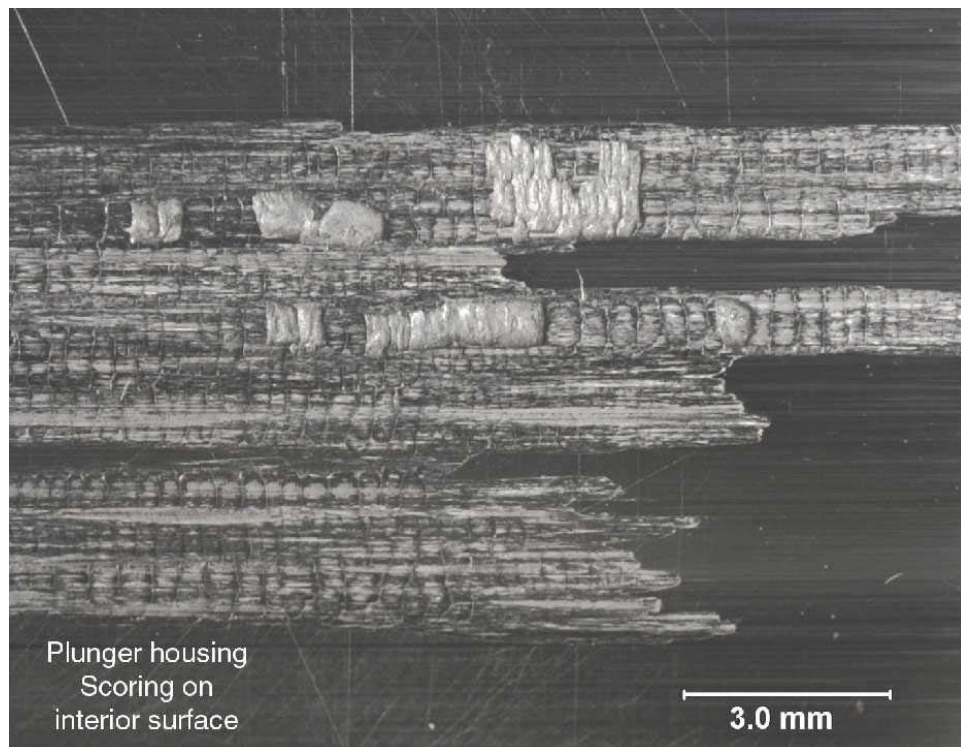
Figure 26 shows a close up of the damaged area of the section barrel. The Secondary Electron Detector (SED) image in Figure 27 is of the wear and scored material seen in the upper -mid section of Figure 26, and was taken with a Scanning Electron Microscope. The image shows how the material appears to be fracturing, as if being ploughed by the plunger. The back-scatter image of Figure 28 highlights the fracture lines in this worn area of the barrel. Another scored area of the barrel is shown in a back-scatter image (Figure 29), which also shows the fracture lines from plowing between the barrel and plunger. These results suggest a third body between the barrel and plunger initiated the wear.

**Figure 26. Scuffed and Worn Section of Barrel**

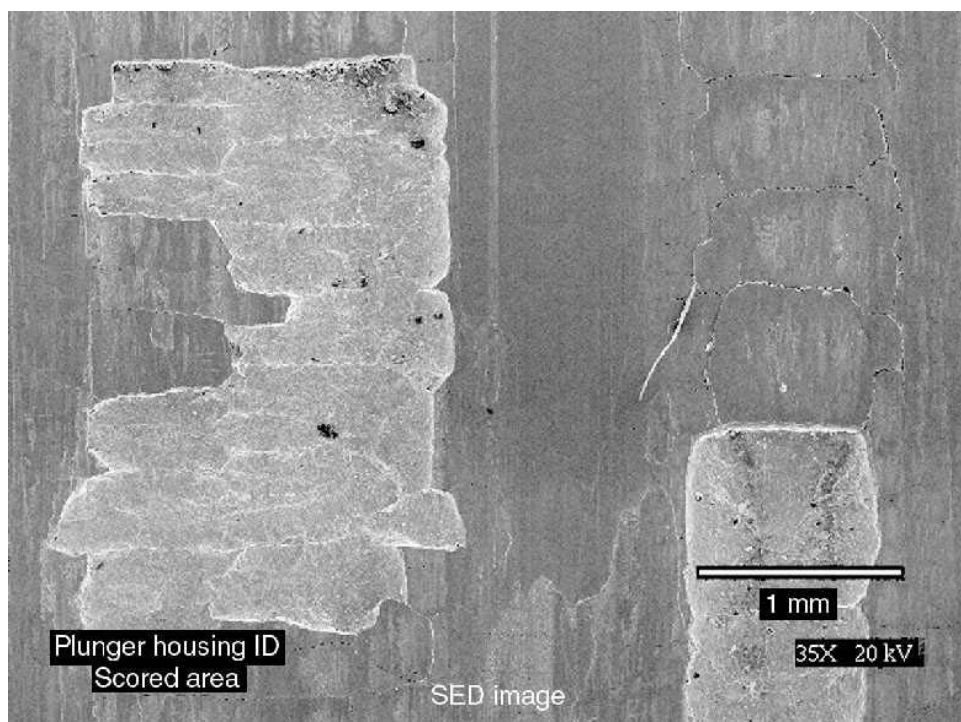
**Figure 27. Scanning Electron Microscope Image of Scuffed Area of Barrel**

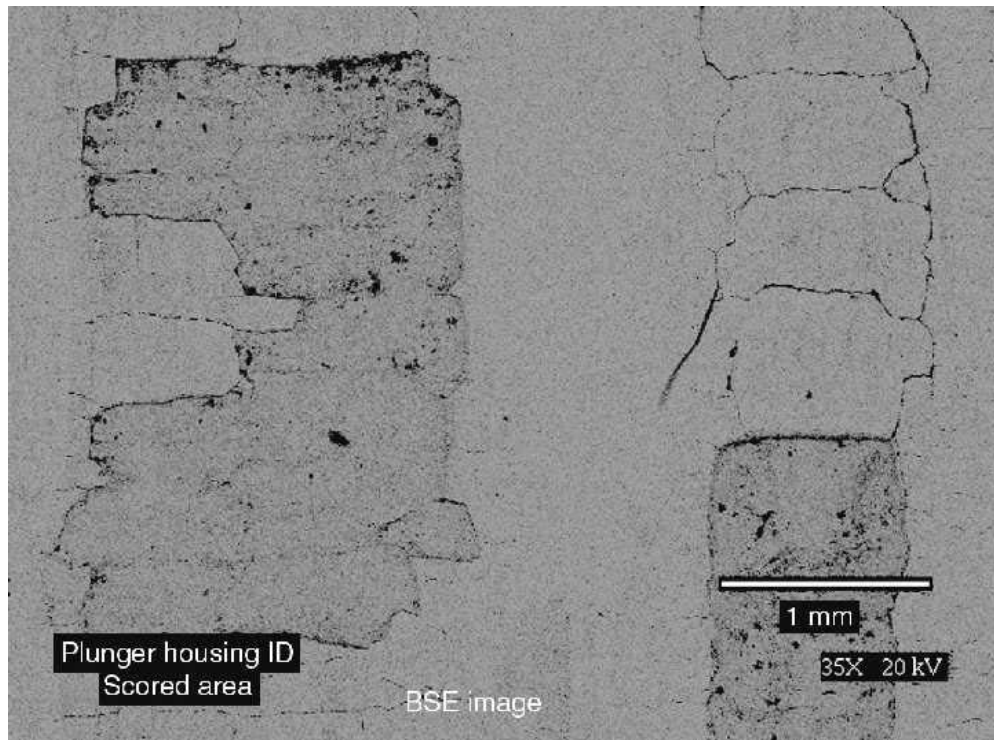
**Figure 28. Back Scatter Scanning Electron Image of Scored Barrel**

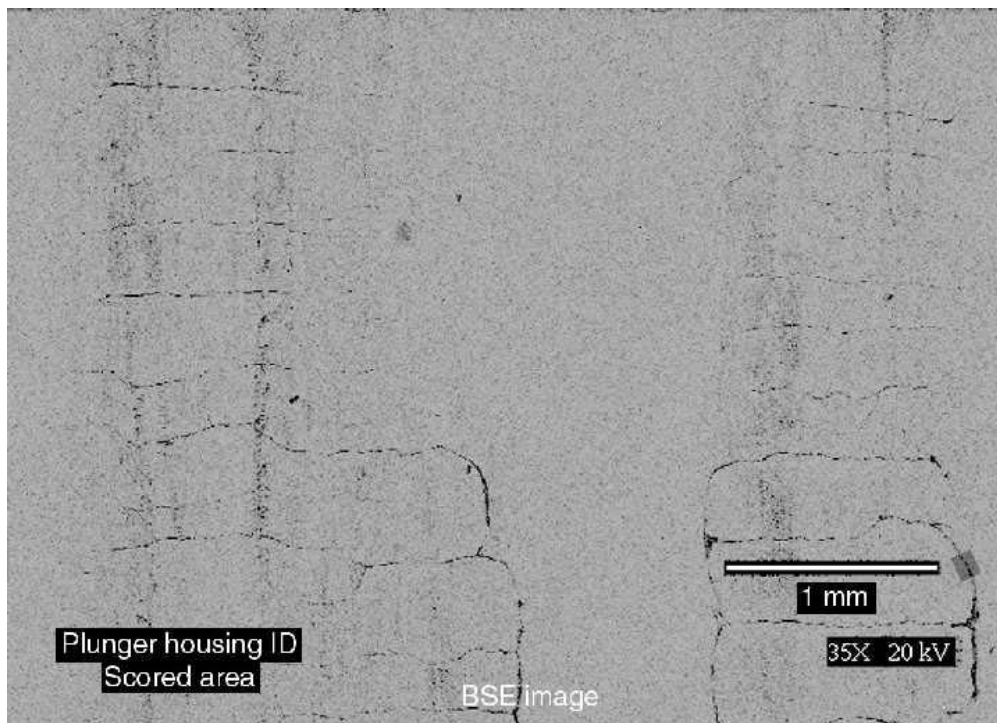
**Figure 29. Back Scatter Image of a Different Scored Area of the Barrel**

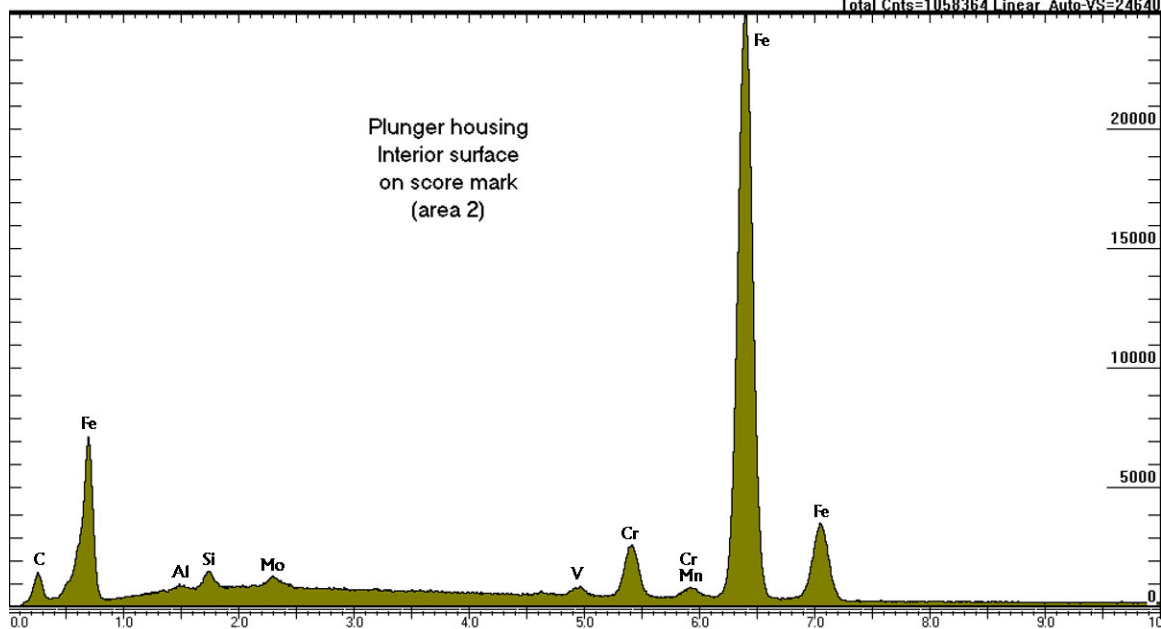
An elemental analysis was performed on an area of the barrel that did not reveal wear and on one of the scored areas. The un-scored area elemental results matched closely with the base metal elemental results. Figure 30 details the elemental analysis of the scored area and Figure 31 details the elements found in a scored area of the barrel. An element that shows up in the scored area is aluminum, which does not show up in the base metal or unscored area elemental scans. The quantity of aluminum is small, thus alloying elements are not seen so it is not certain if the aluminum is from an alloy or from an abrasive such as aluminum oxide.

Figure 31. Elemental Scan Results for Scored Area of Barrel

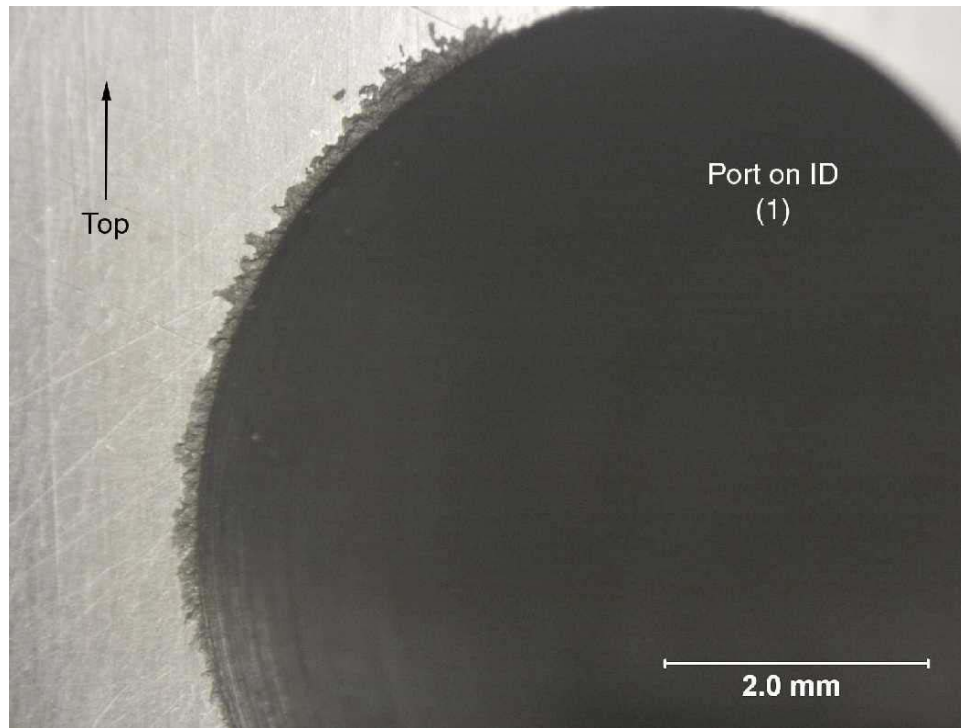
An image of a fuel fill/spill port on the fuel injection barrel is shown in Figure 33, with evidence of chipping on the upper edge of the port. Chipping on the port has been known to occur with debris that is sheared between the plunger and port edge during the injection process. The image suggests some debris may have initiated the chipping of the port edge, than the port edge debris caused the further damage to the barrel and plunger. However the damage around the port may be due to erosion when the high-pressure fuel exits through the port during the spill event. This is further supported by the fact that the barrel is not damaged immediately above and below the ports.

**Figure 33. Barrel Fuel Port with Evidence of Chipping on Port Edge**

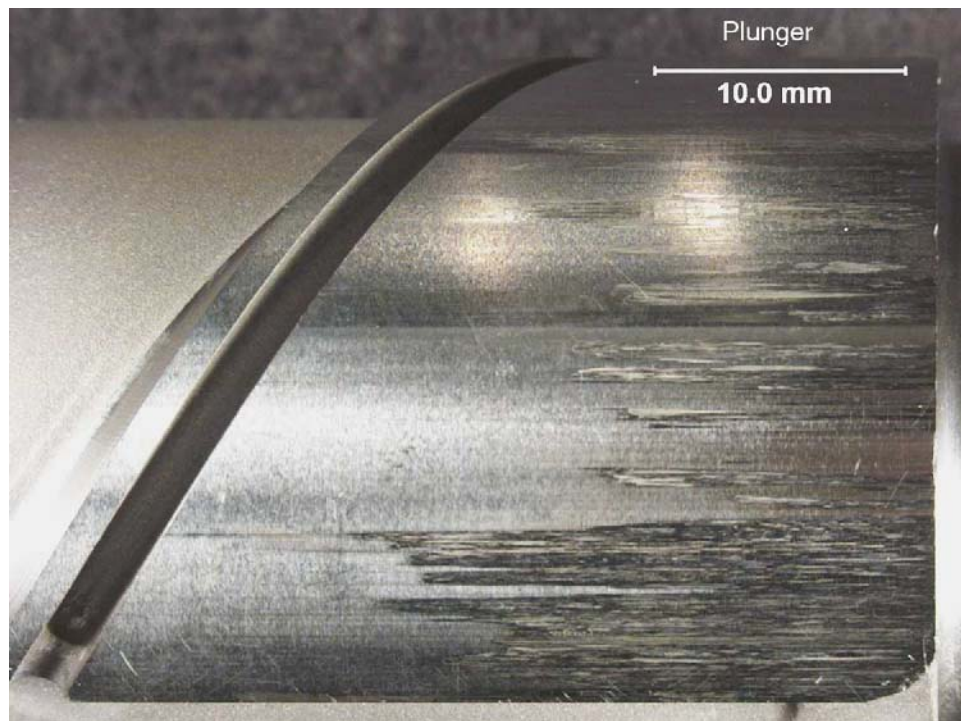
The damaged plunger was also examined. Figure 34 shows a damaged section of the plunger that was examined. The SED image of a worn area of the plunger is shown in Figure 35. Evident in the figure is vertical and circumferential fracture lines. Figure 36 also shows circumferential fracture lines evident on the plunger surface as highlighted by back scatter imaging. A magnified image of the cracking is highlighted by backscatter imaging in Figure 37. On the cracking, plastic deformation of the hardened surface layer appears to be causing cracks that propagate parallel to the surface and cause small pieces to eventually spall off. The depth of the carburized case is around 300 micron as shown in Figure 38. An undamaged area of the plunger is shown in Figure 39. The core and surface hardness of the plunger were found to be Rc 34 for the plunger core hardness and Rc 56 for the surface hardness.

**Figure 34. View of Damaged Injection Pump Plunger**

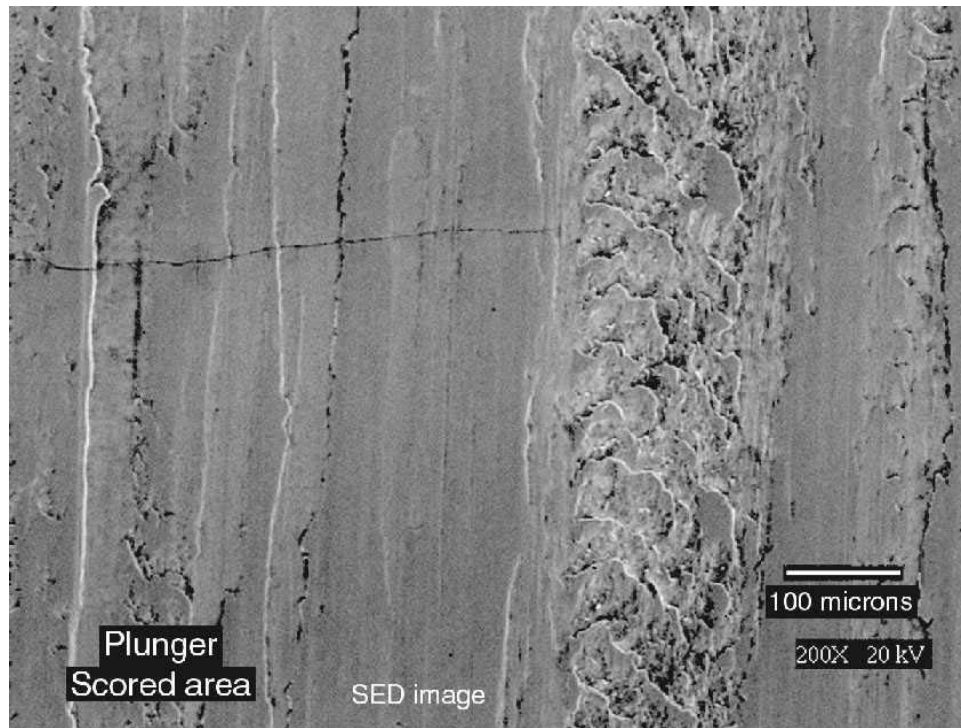
**Figure 35. Plunger Scored Area with Evident Fracture Lines**

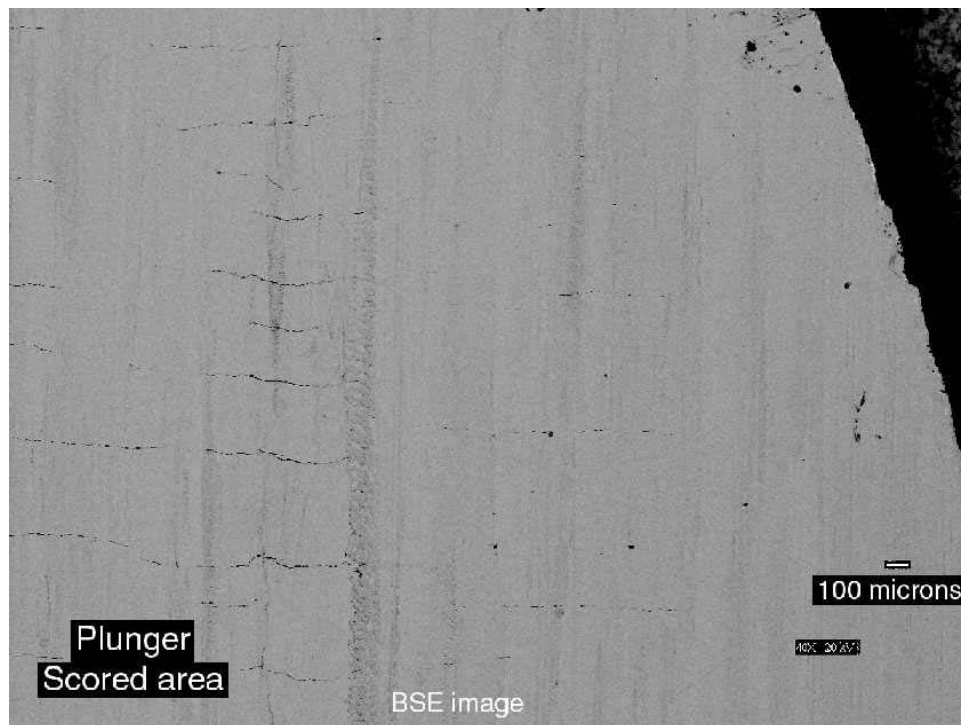
**Figure 36. Circumferential Fracture Lines on Plunger Surface**

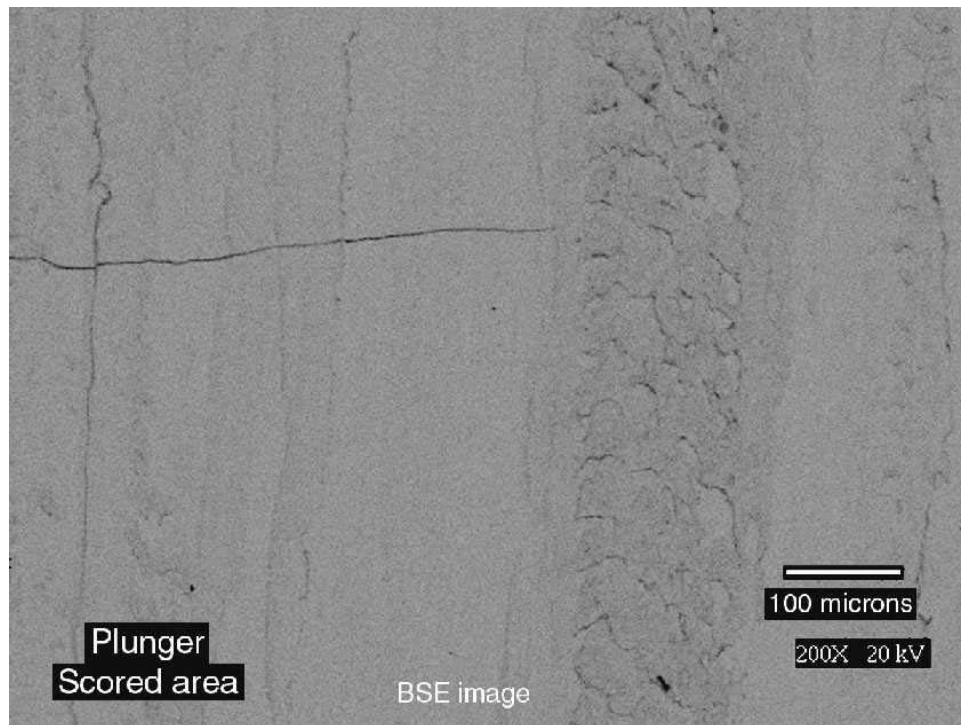
**Figure 37. Close up of Cracked Surface of Plunger**

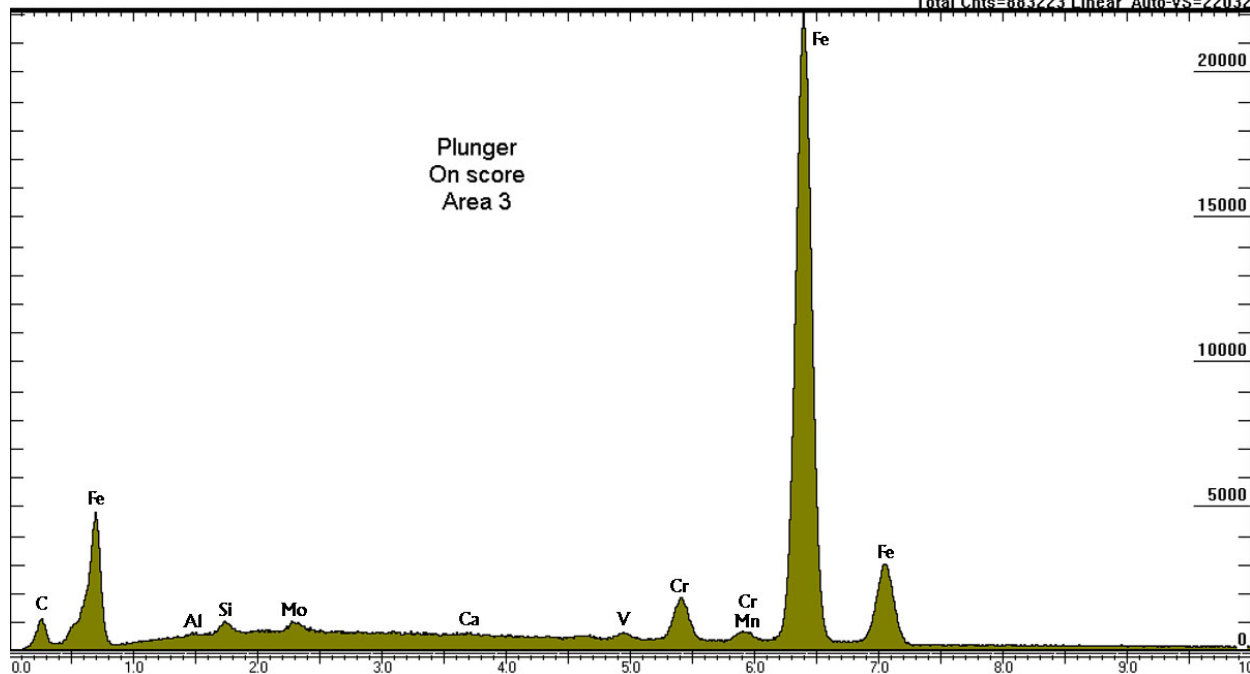
Elemental scans were performed on the base material and on a damaged section of the plunger to determine if foreign materials were present in the wear scars. As seen with the barrel, the plunger revealed a small aluminum peak in the damaged areas as shown in Figure 40. The undamaged area did not show an aluminum peak as seen in Figure 41.

Figure 40. Elemental Scan of Plunger Damaged Surface

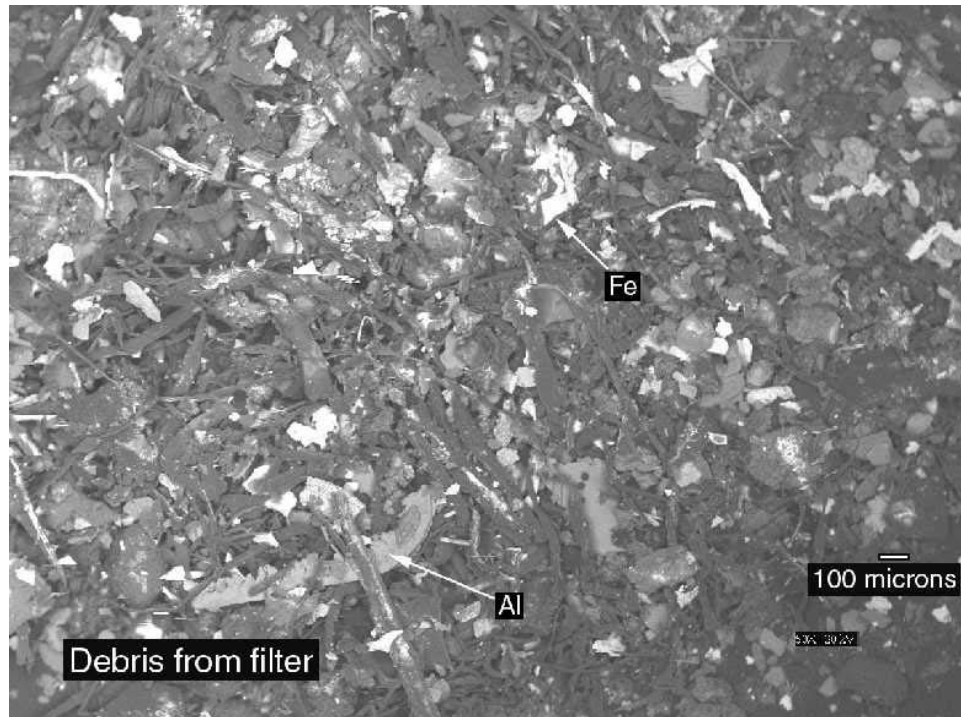
**Figure 43. Aluminum and Iron Particles from Fuel Filter Debris**

The analysis suggests it is likely a contaminant entered the fuel injection system and caused the rapid wear. It is likely the contaminant may have been introduced during the disassembly/assembly processes that were carried out in order to check plunger activity. Although considerable care was taken when handling the components, it is possible the plunger could have been damaged in the disassembly/assembly processes.

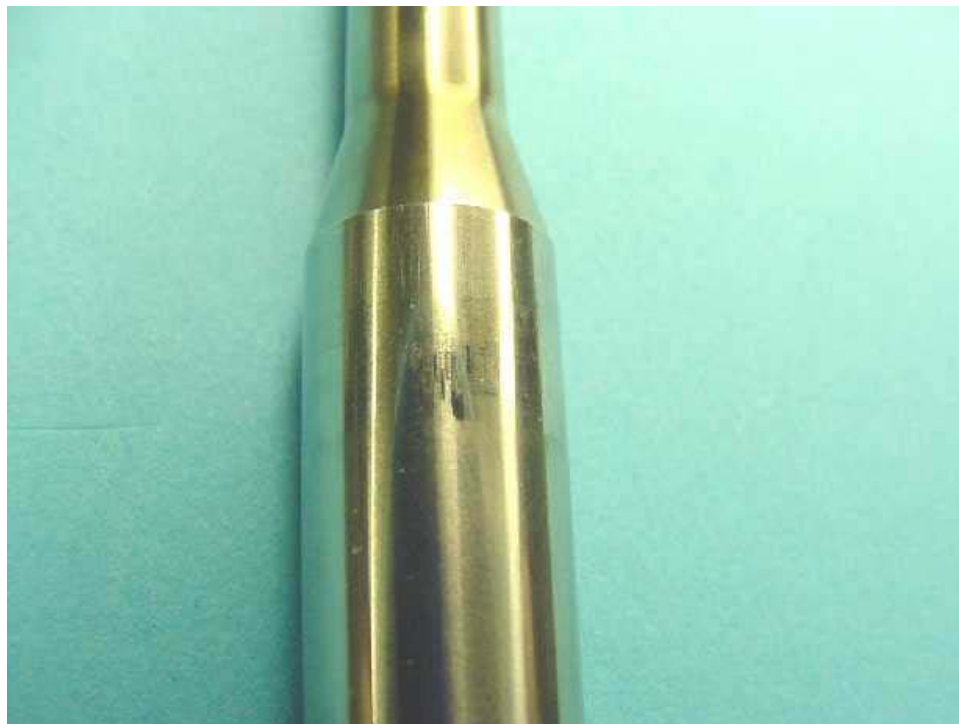
**Figure 44. Wear Scar on Fuel Injector Pintle**

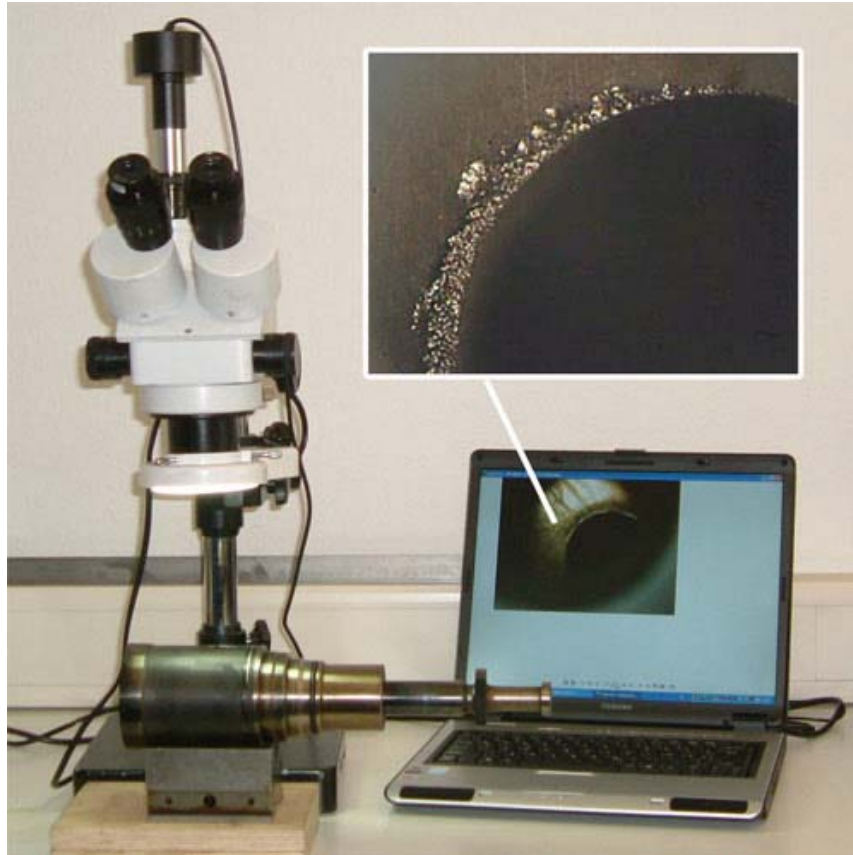
**Figure 46. Documented Cavitation from Commercial Diesel Service Company**

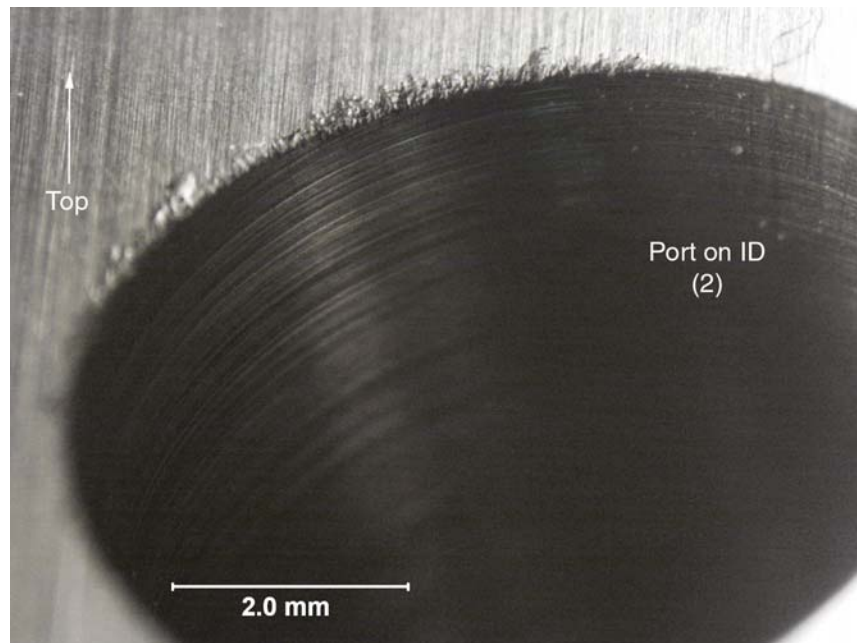
**Figure 47. Barrel Port from JP-5 Test Program with Evidence of Cavitation-like Erosion**
